## CATASTROPHIC FAILURE OF AN UNDERGROUND DAM

### THE SITUATION

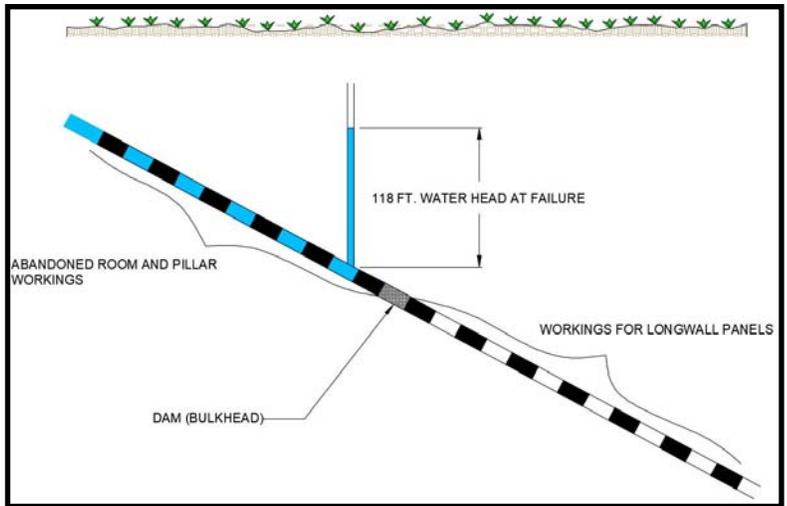
A 730 ft. long dam was installed in an underground coal mine in Southeast Ohio. The purpose of the dam (or hydraulic bulkhead) was to eliminate the downslope groundwater seepage from abandoned workings that was constantly flowing downslope and was collecting at lower elevations where active mining operations were taking place. Consequently, this water had to be continually pumped out and treated in surface facilities before it could be released into a nearby stream. The dam would eliminate these efforts. Figure 1 illustrates the purpose of the bulkhead in eliminating the downslope seepage issues.

FIGURE 1 CROSS-SECTION ILLUSTRATING DAM LOCATION DOWNSTREAM FROM FLOODED ABANDONED WORKS AND UPSTREAM FROM ACTIVE LONGWALLING

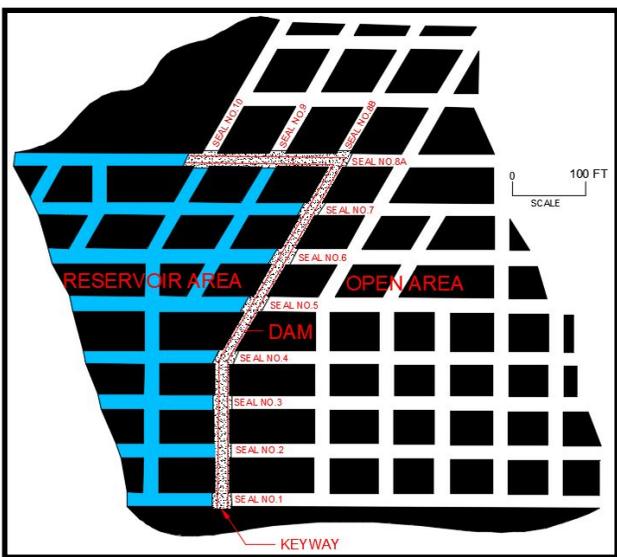
FIGURE 2 PLAN VIEW OF THE CONCRETE BULKHEAD

The layout of the concrete hydraulic bulkhead is shown in Figure 2. As can be seen in Figure 2, what was constructed was essentially a continuous concrete (grout) wall from solid coal to solid coal. The bulkhead was made to be 20 ft. thick and filled the mine void space from coal pillar to coal pillar and from roof to floor at the height of about 6 ft. or greater where roof cave existed. The 20 ft. wide dam was seated in a soft floor. In an attempt to cut off underseepage in the soft floor, a 12 ft. wide concrete keyway up to 2 ft. deep into the floor was installed along the alignment of the wall (see Figure 2). The floor in this area was claystone which was heavily fissured, and extended well beyond the depth of the keyway.

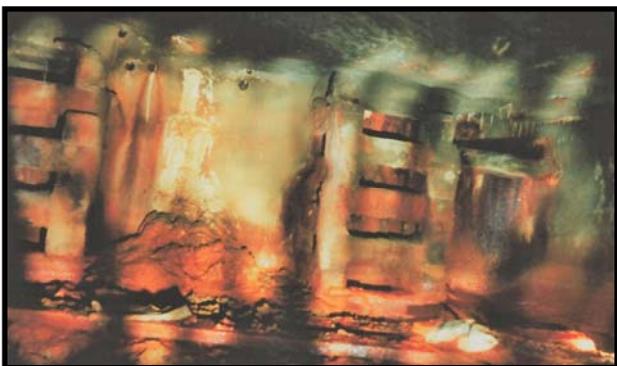
FIGURE 3 DOWNSTREAM SEEPAGE EFFECTS AT SEAL NO. 7. PHOTO TAKEN AFTER FAILURE

After construction, groundwater began collecting behind the bulkhead. Reports of roof, seal, rib, and floor leakage as well as muddy floor conditions were reported throughout the entire time of impoundment. After about 100 days, seepage through Seal No. 7 (see Figure 2) accelerated with seepage rates reaching over 75 gpm with the water only about 20 ft. high (or 8.7 psi water pressure against the wall). Figure 3 shows photographic evidence of the seepage through the roof above Seal No. 7. Remedial grouting in the roof reduced seepage to

pre-accelerated levels of about 10 gpm. As the water pressure continued to build, the Seal No. 7 roof had to be grouted again because of seepage rates similar to before. At this point, the water behind the bulkhead had reached about 95 ft. (41 psi) in 600 days. After reducing the seepage to about 4 gpm, flow immediately began to increase again. Also, it was reported that 4 in. deep water was flowing from Seal No. 10. After the impounded water reached a height of 118 ft., the mine floor blew out at Seal No. 10.

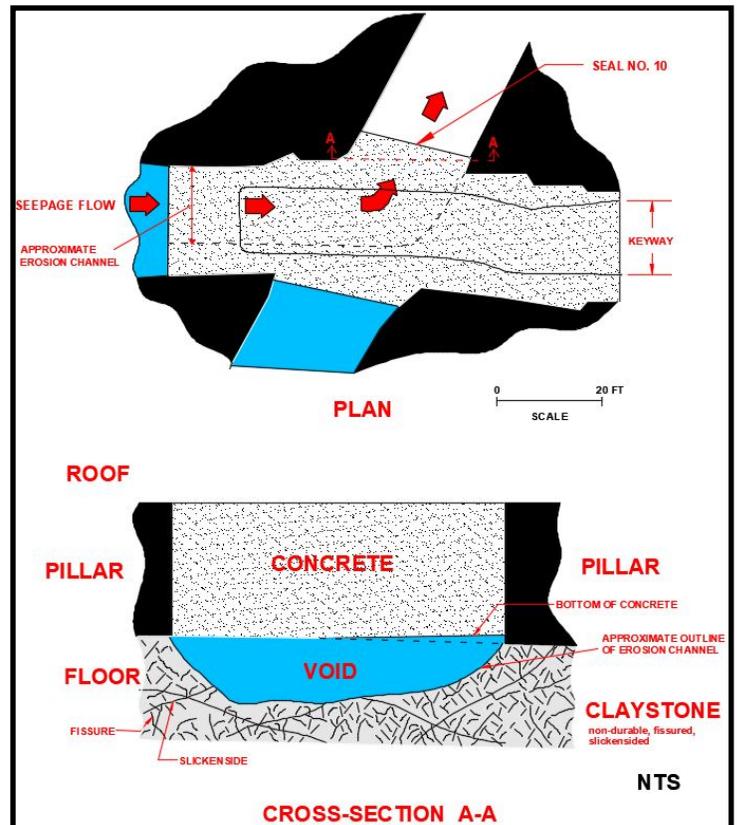
As a result, 1 billion gallons of contaminated underground reservoir water rapidly flowed down through the floor of Seal No. 10 and inundated the active portion of the mine. The area of blowout resulted because of a designed and constructed weak spot in the dam. The failure conditions at Seal No. 10 are illustrated in Figure 4. As can be seen in this figure, the failure was through a fireclay (claystone) floor. This claystone was erodible and was significantly permeable due to the presence of abundant fissures. This combined with a seepage path which could avoid the constructed keyway, and where a coal corner exists, which commonly contains significant fracturing, ultimately caused failure.

FIGURE 4 DAM BREACH CONDITIONS AT SEAL NO. 10

This is a case where the in-house designer was unaware, and they did not recognize the importance of employing a qualified geotechnical consultant when considering the potential impact of failure, even though the up-front costs would be greater. Here was a case where the risk (i.e. likelihood and severity of failure) was misjudged. This was manifested in the constructed conditions, which demonstrated a fundamental lack of understanding of seepage phenomena and effects. Moreover, continued seepage which could not be abated by grouting as the water impoundment height increased should have been recognized as a clear sign of incipient failure.
